Monitoring Data RecordProject Title: B-3157 (Michael's Branch Site) COE Action ID: 200020843WQC Number: 3467Stream Name: Michael's BranchCity, County and other Location Information: Davidson County, Bridge #74 & #76 over
SR 1242 and Michael's Branch and approaches on US 29/64/70 & I-85 Business.Date Construction Completed: 9/5/07 Monitoring Year: (5) of 5Ecoregion: _____ 8 digit HUC unit 03040103

Michael's Branch

Year 5 Winter – January 2012

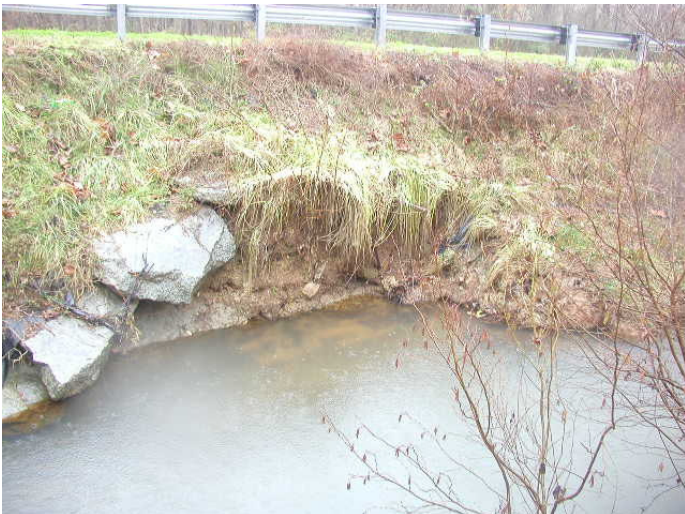
| Bank or scour erosion present? | Erosion on left bank at the end of the crossvane arm | Erosion on right bank behind right crossvane arm | | | |

STA. 15+30 -Y2 – Erosion on left bank at the end of the crossvane arm located upstream of PP#1

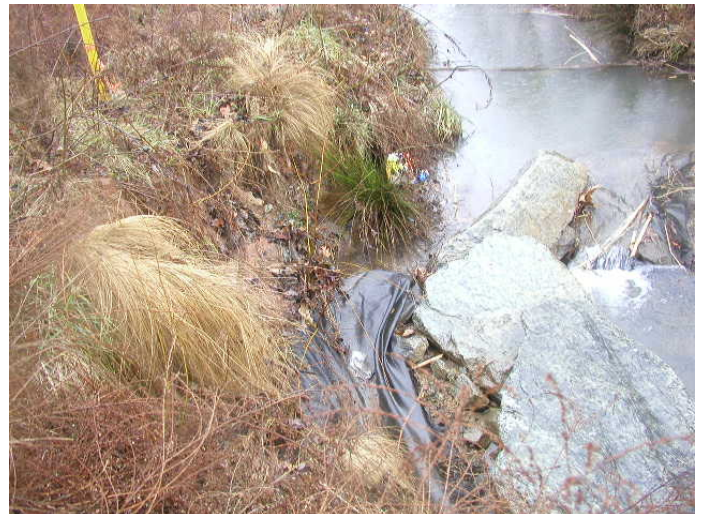
| Is water piping through or around structure? | | Water flowing over top of crossvane | Water flowing over top of crossvane | | |

Sta. 0+50 -Ramp C- Erosion behind right arm and water flowing over top of crossvane located b/t PP#3 and PP#4

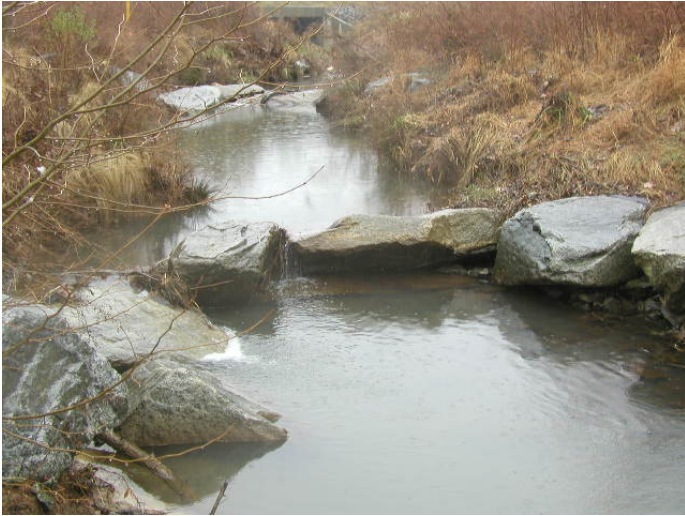
Sta. 1+00 –Ramp C- Water flowing over top of crossvane
